RESTORING A RESIDENCE

926 Fifth Avenue

*New York City*

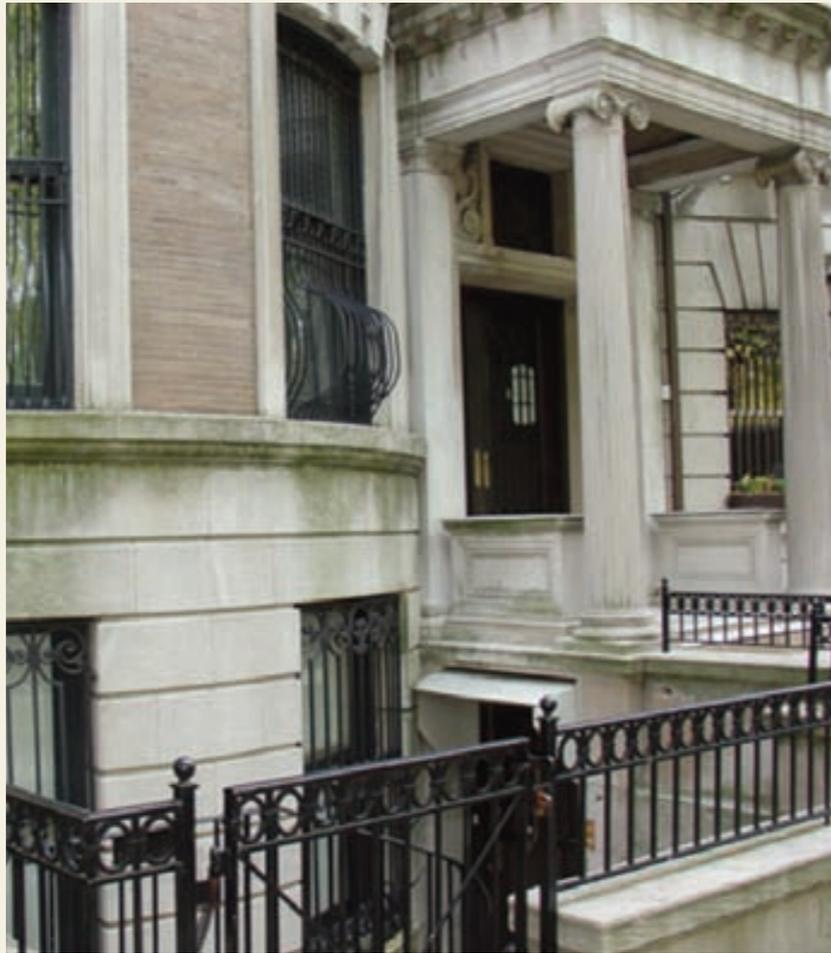
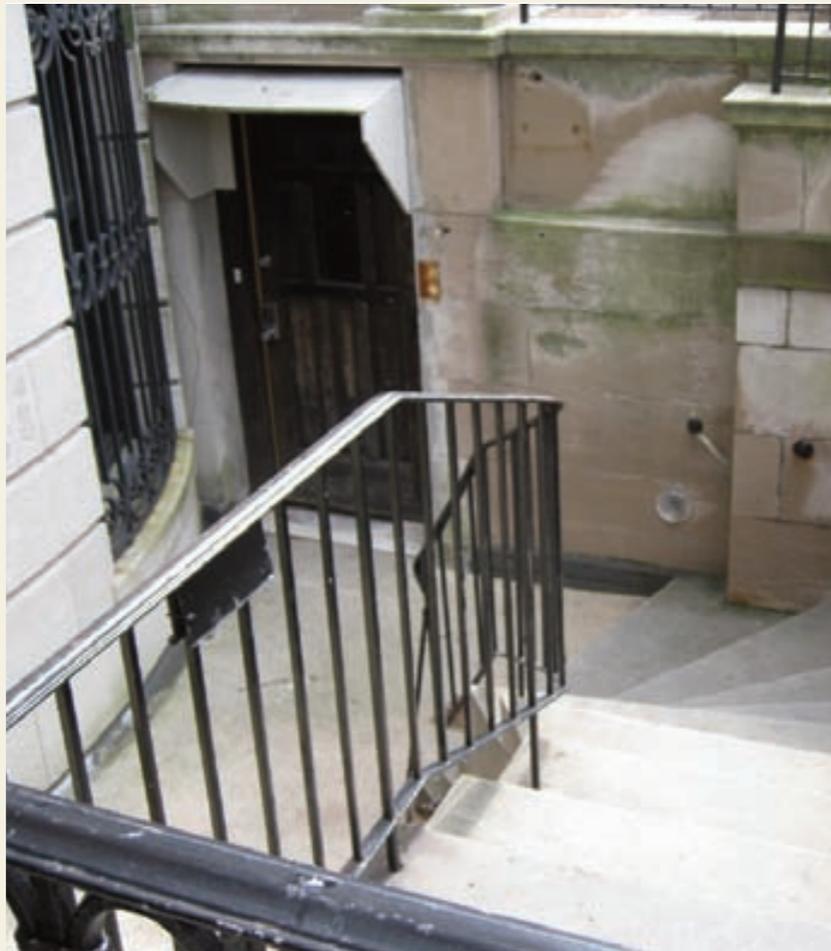
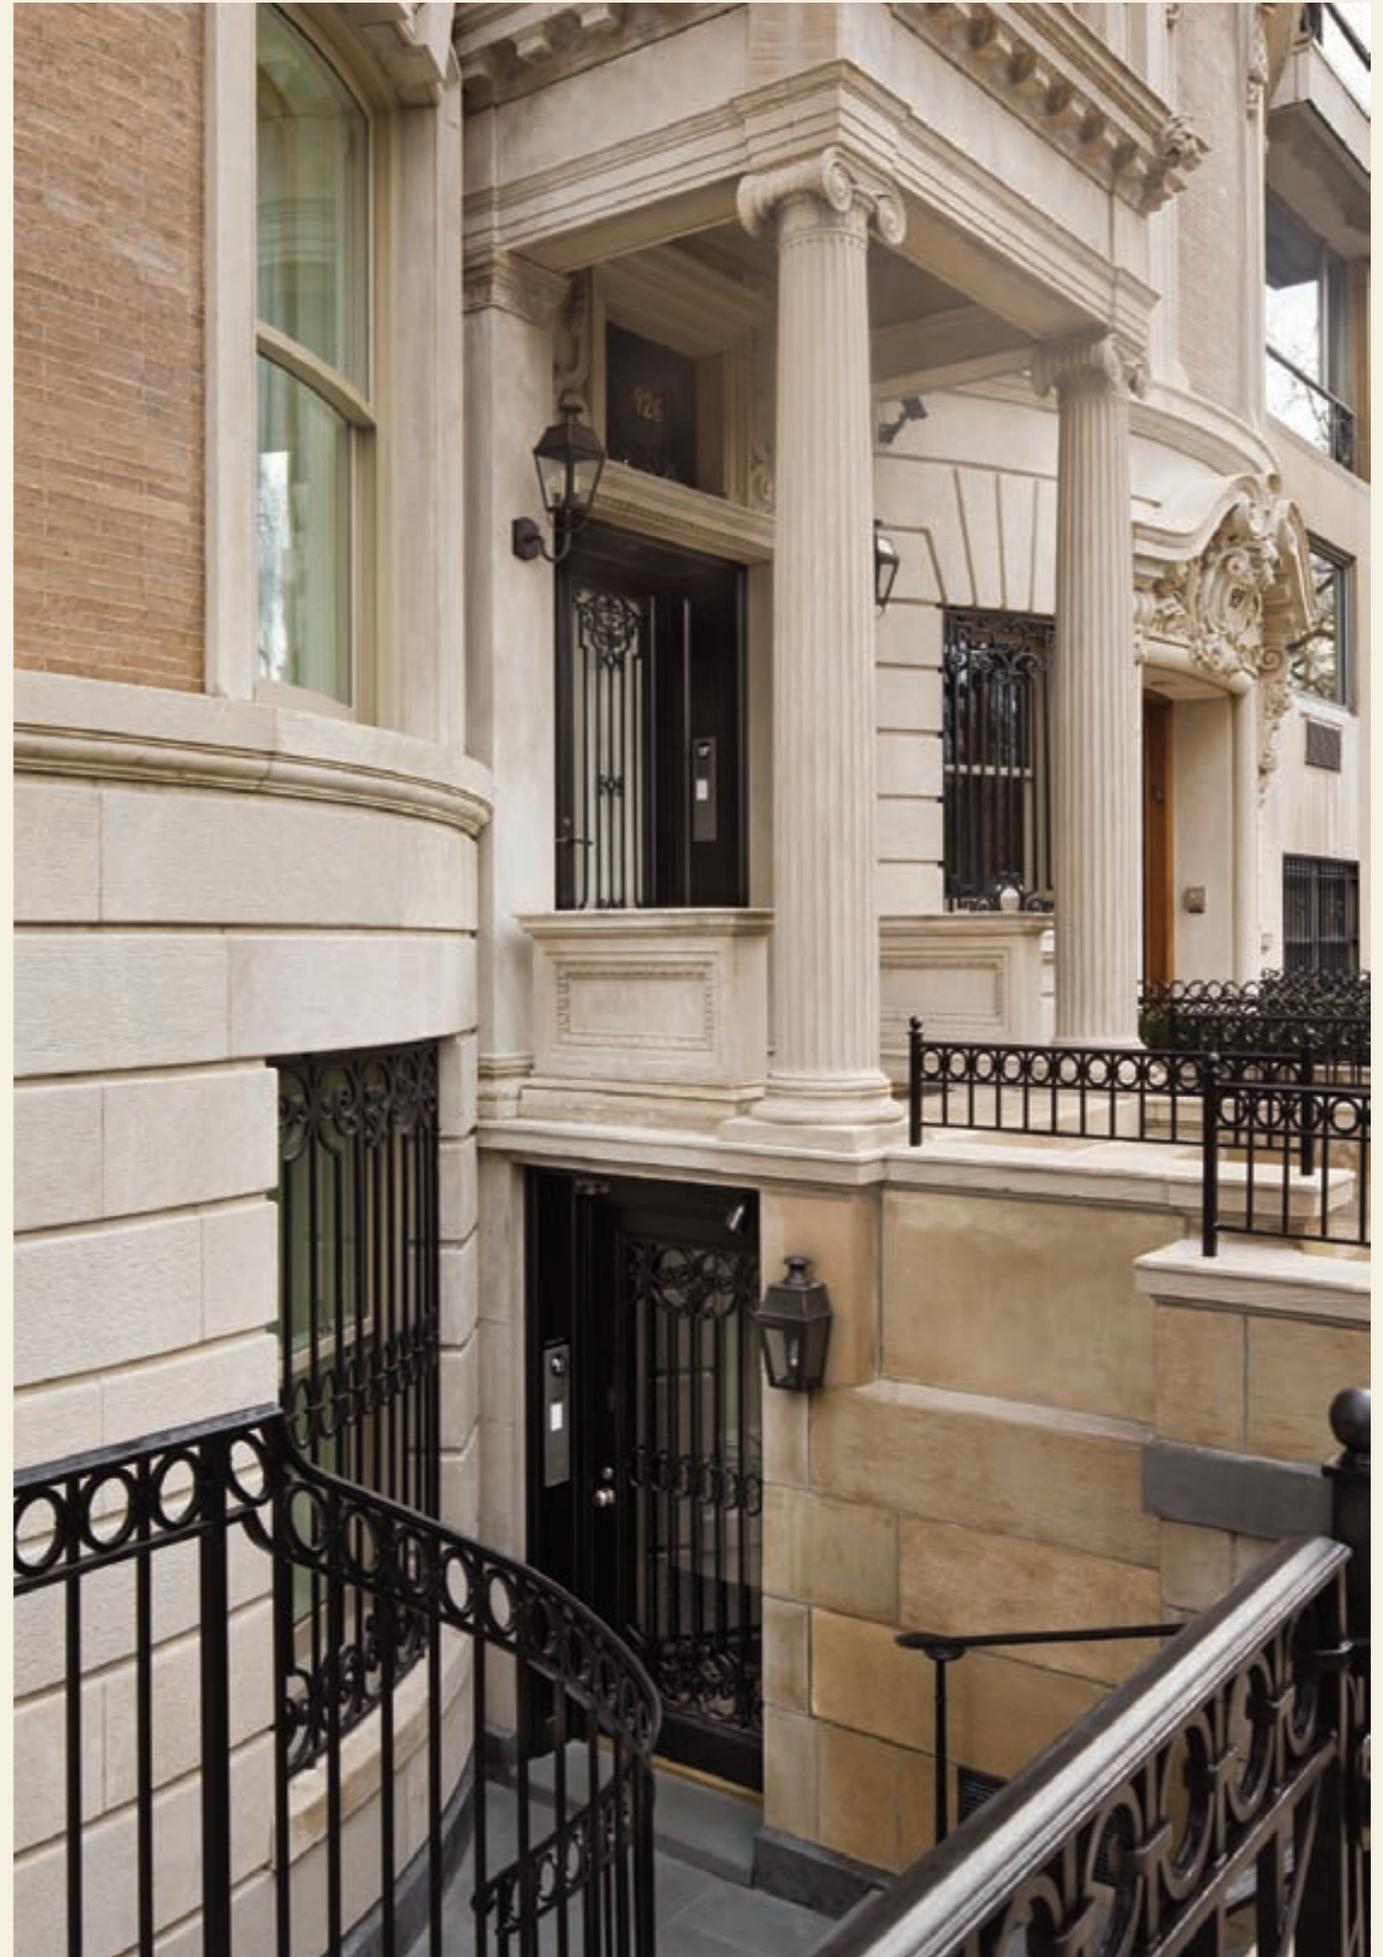
## Entrances

The main entrances required a substantial amount of cleaning and masonry patching. There was no available information about the original lower entrance, so the Architect worked closely with the LPC to design something that was in keeping with the existing elements of the house, as well as the fabric of the neighborhood. Fortunately, everyone agreed that the removal of the “belly” gates on the windows of the Main Floor was historically relevant.

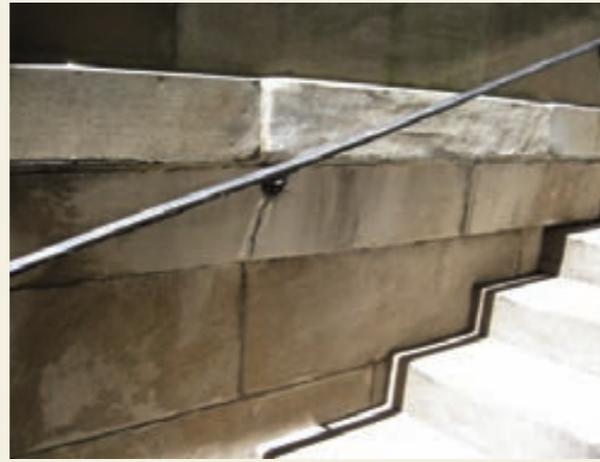
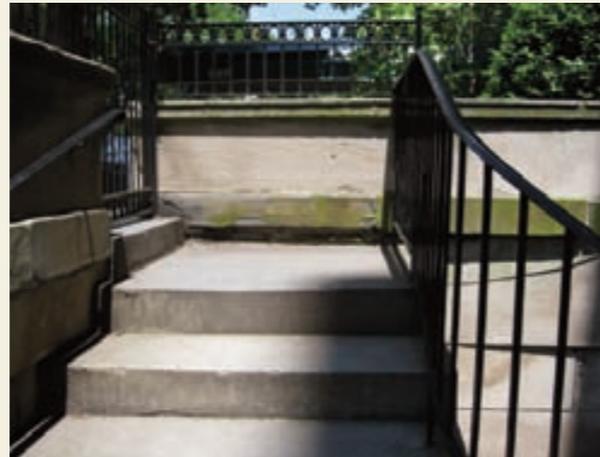
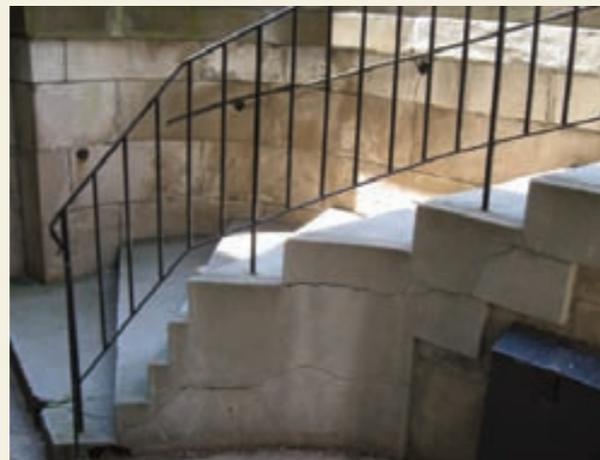
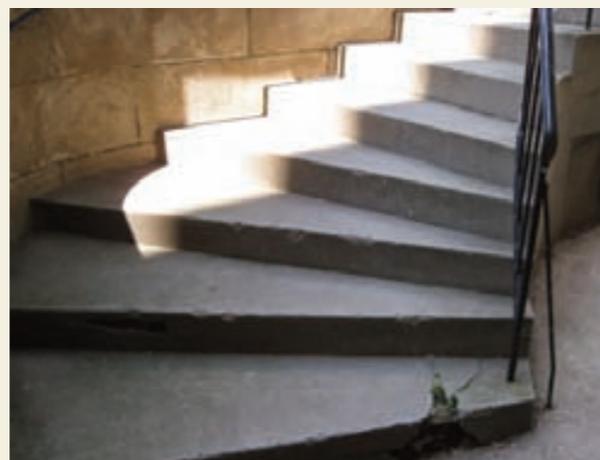
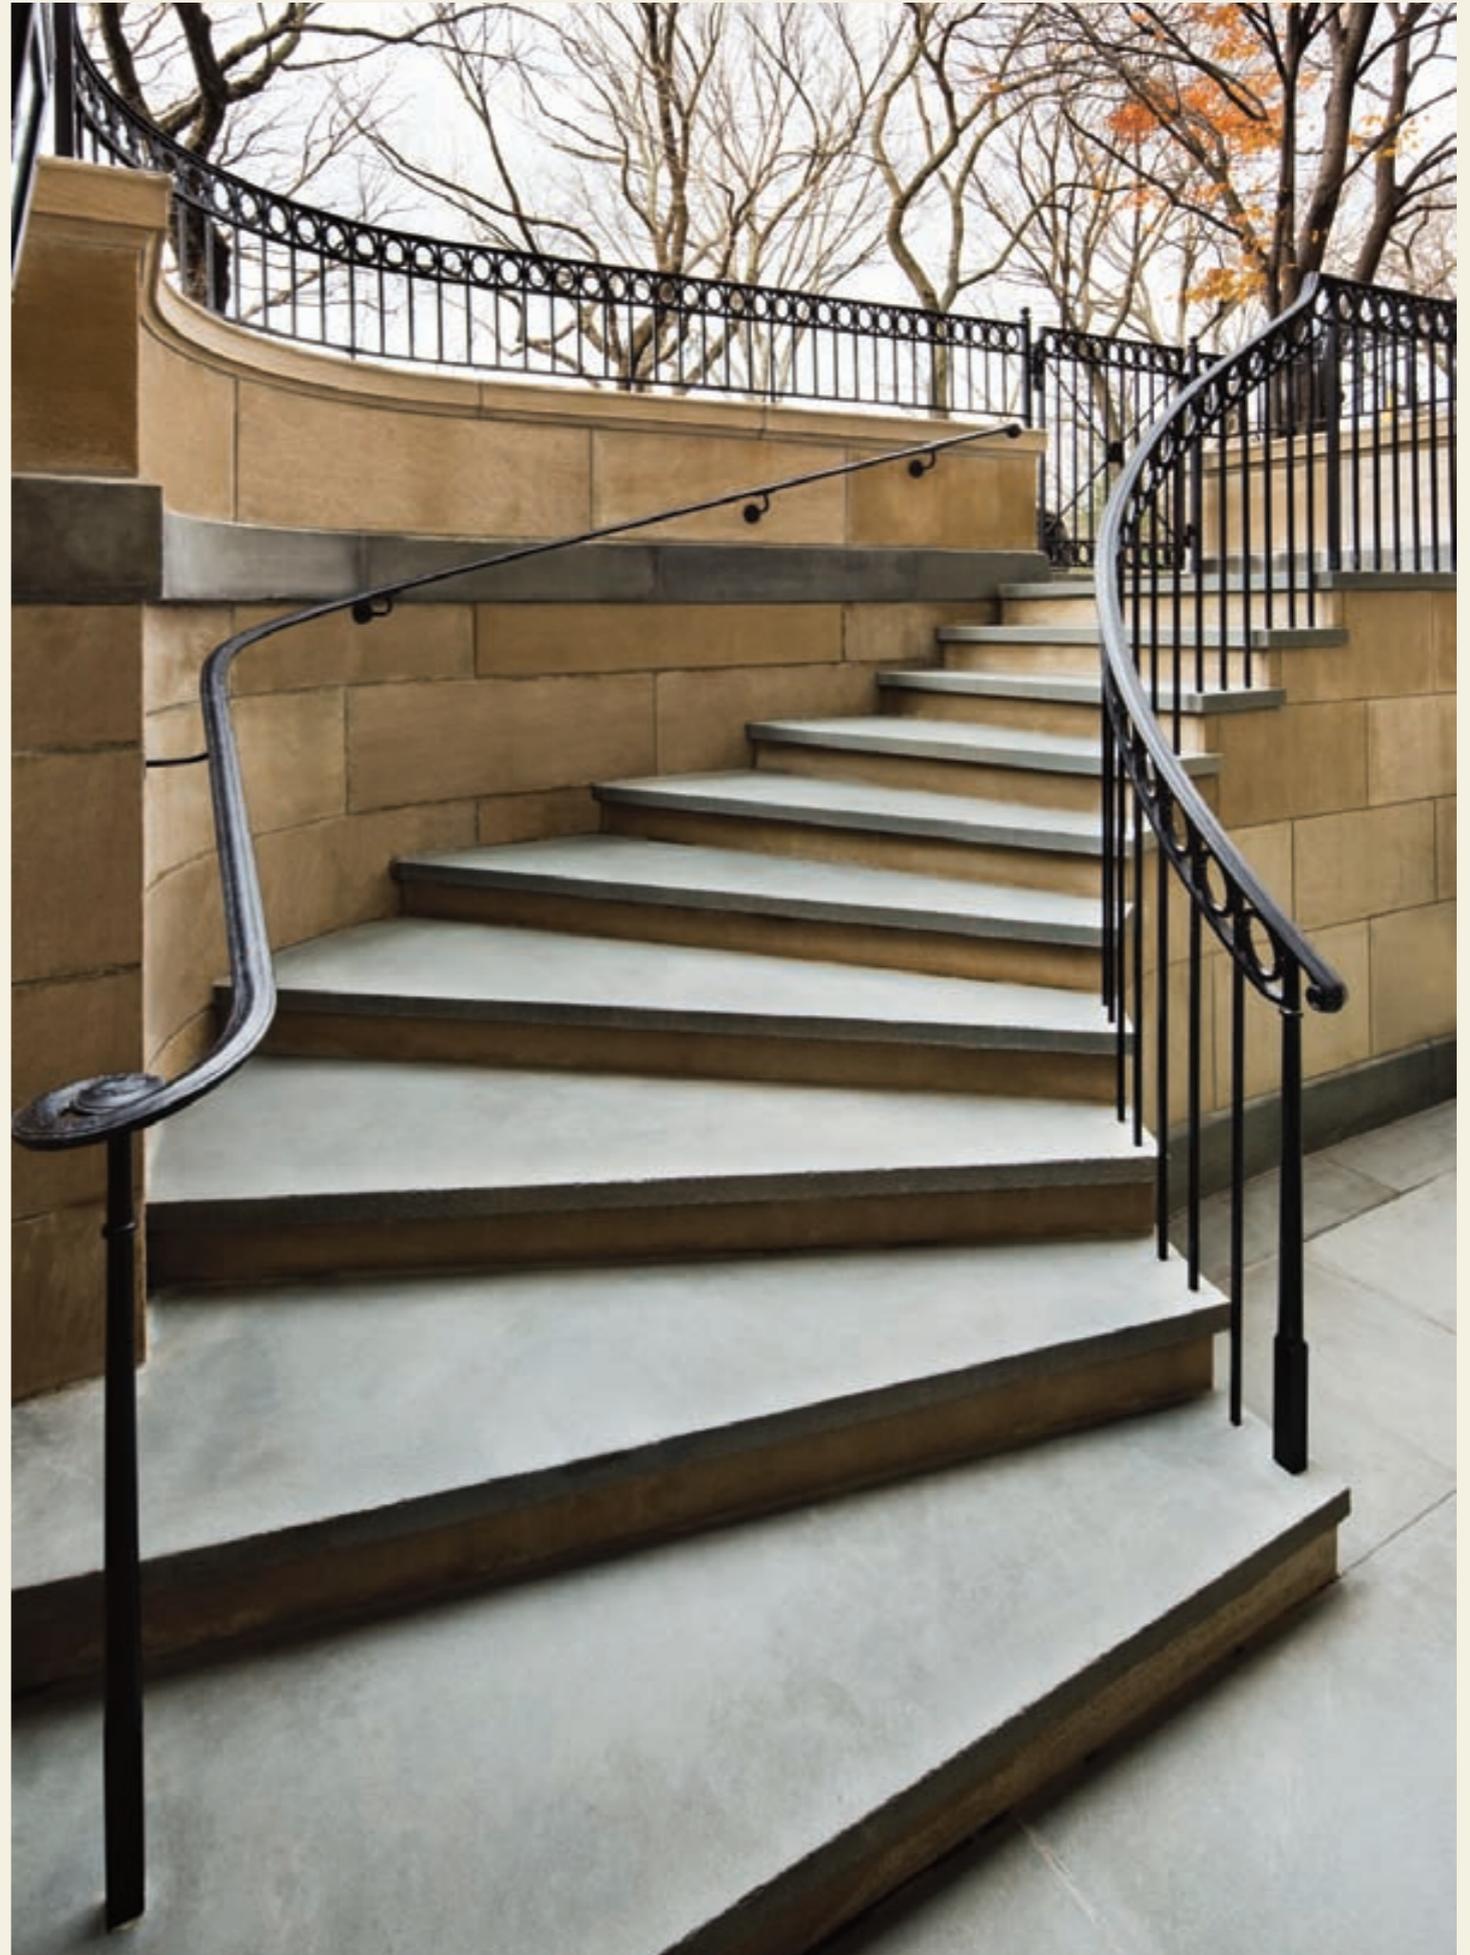
## The Areaway

Repair of the existing masonry stairway revealed that the original stone steps had been replaced some time in the past. In addition, the existing steps had been patched with a cement stucco that was deteriorating and was a poor match to the existing limestone retaining walls, which were themselves structurally un-sound. There was striking evidence of significant frost heave along the entire top band of limestone. Much of the original limestone was cleaned and patched, but where that was impossible, matching Indiana limestone was installed.

The LPC agreed to allow the re-paving of the Areaway floor with bluestone, instead of concrete, so that it was natural to re-surface the repaired steps with matching bluestone, as well. This new bluestone was carefully selected so that it matched the existing bluestone base of the building and the enclosing low walls.

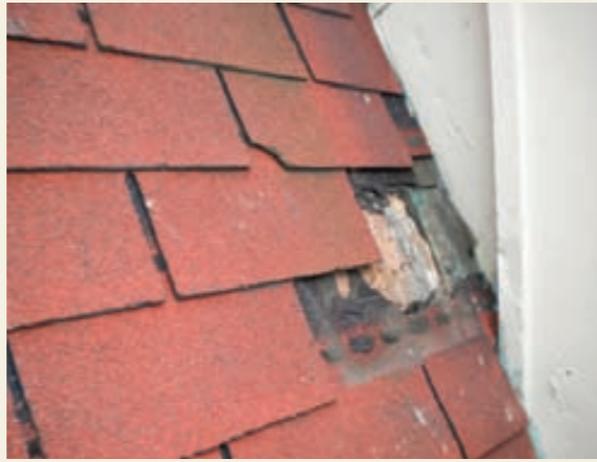
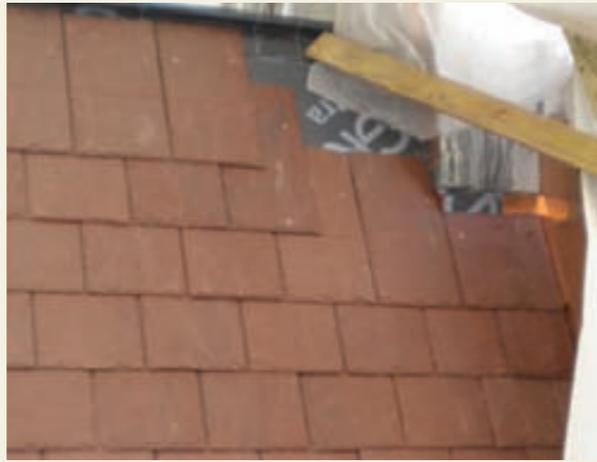
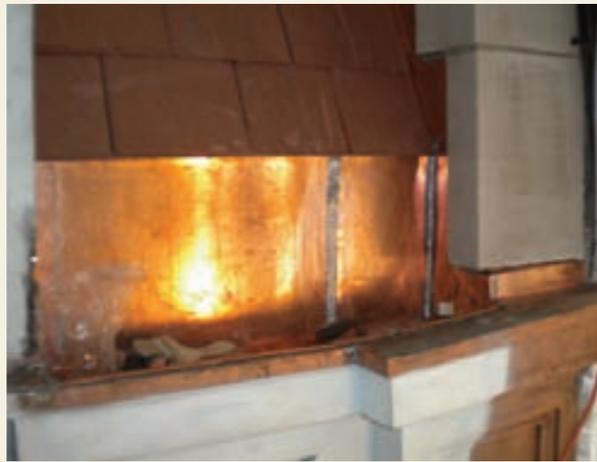
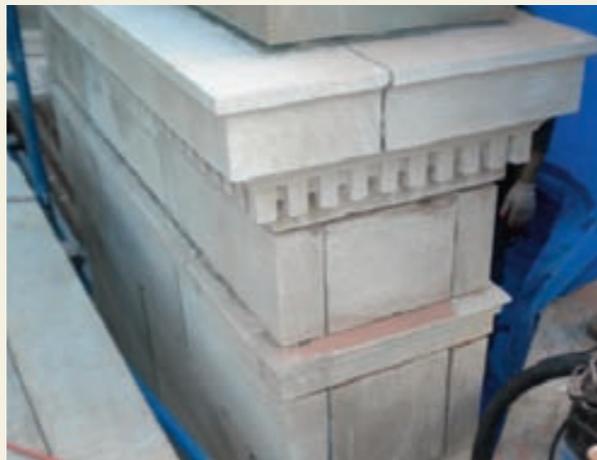
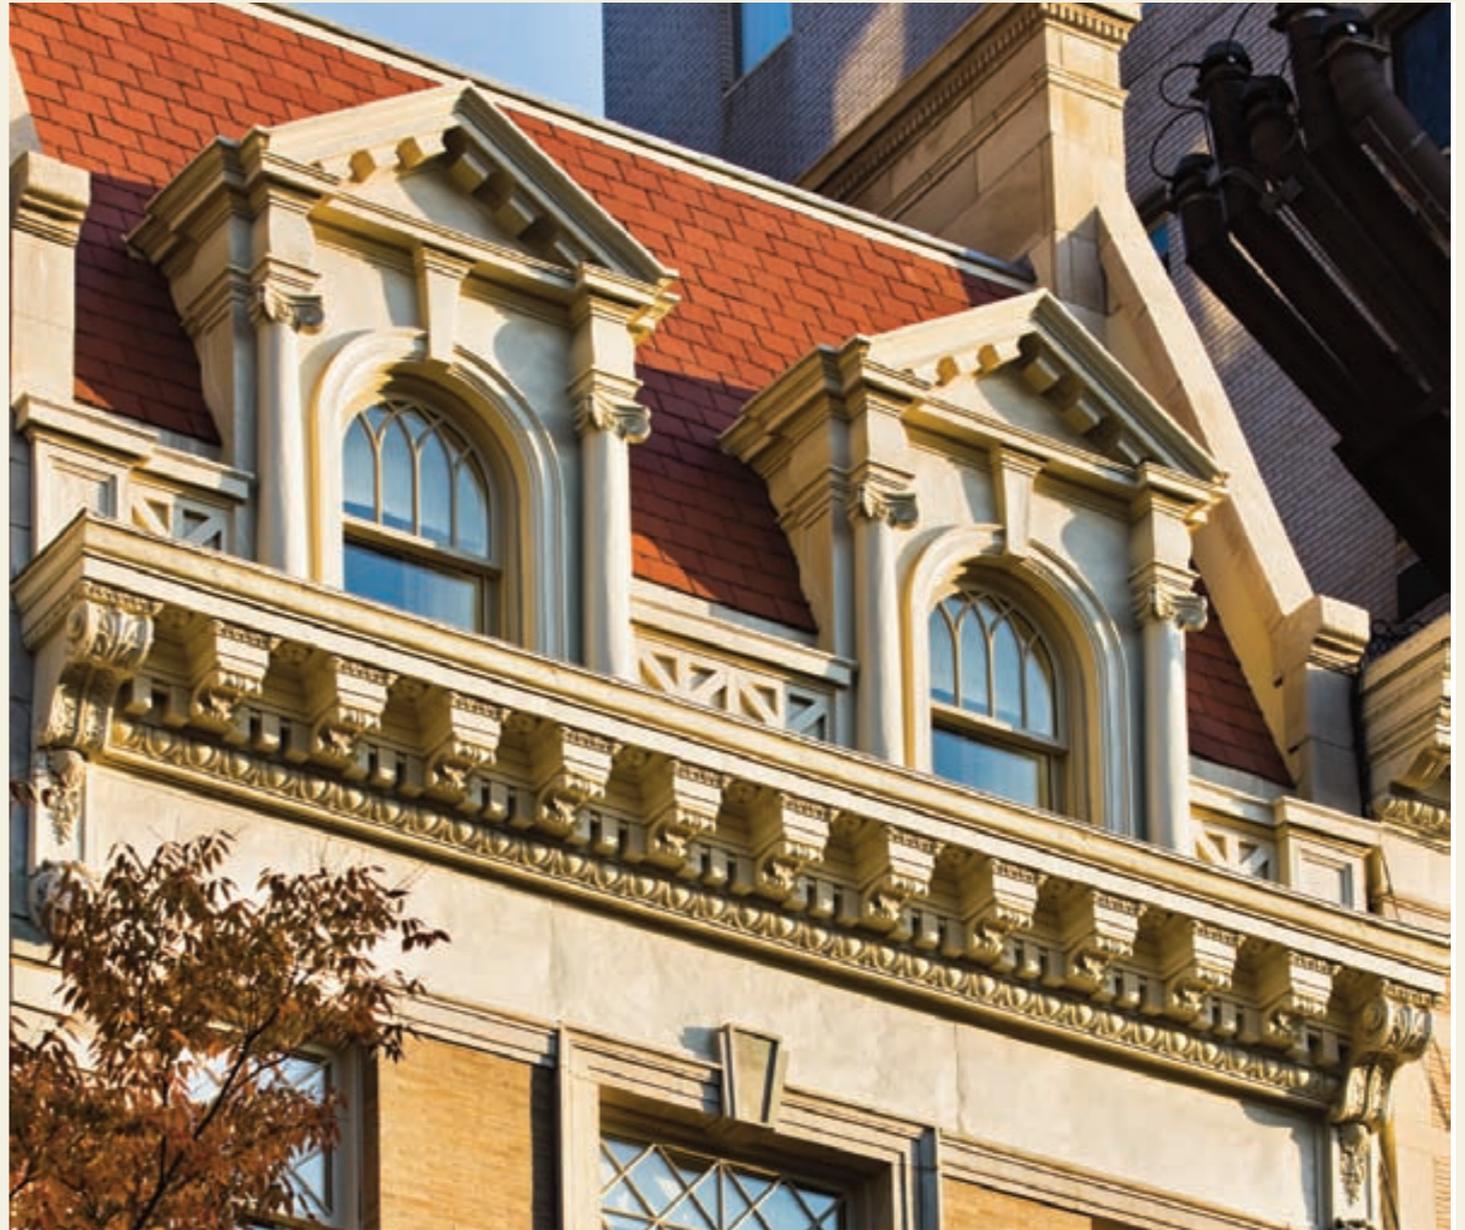
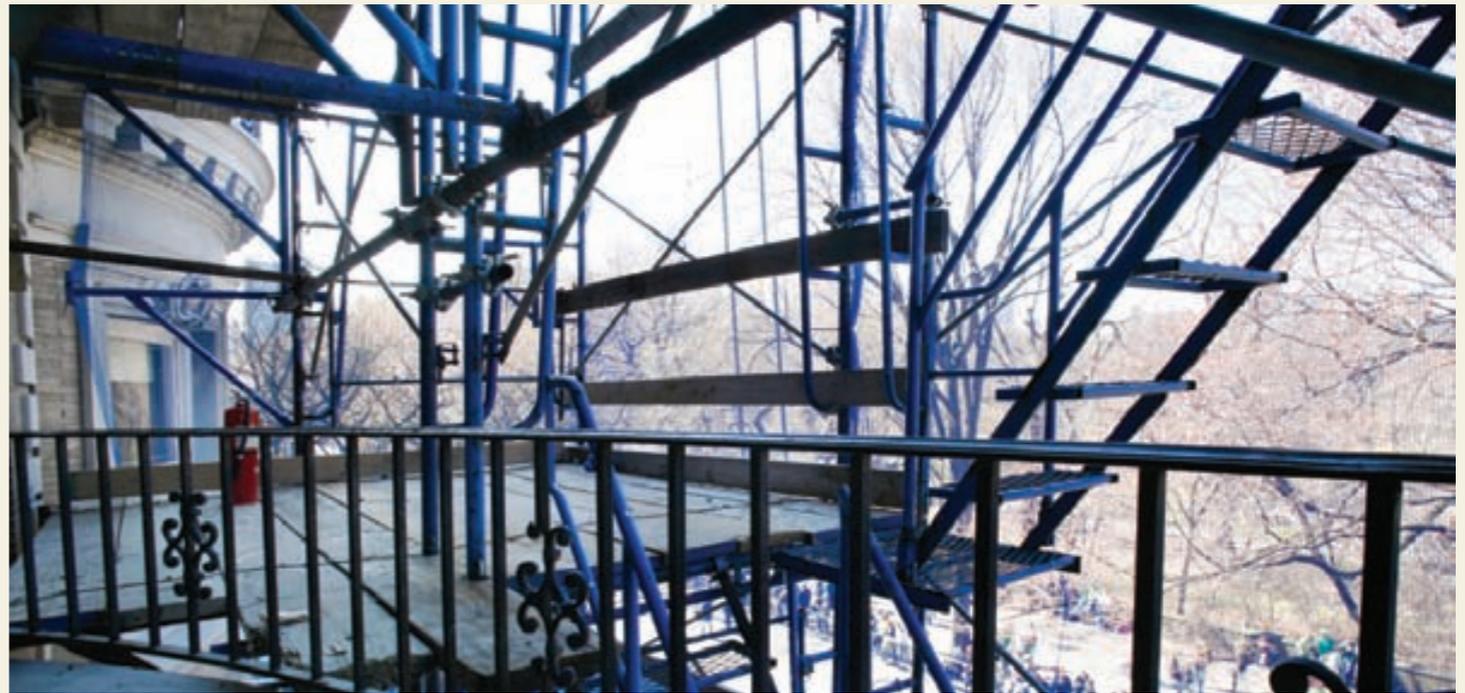
## Mansard Roof

Sometime in the past, the original slate tile shingles of the mansard roof had been replaced, and the building was purchased with failing asphalt shingles. The color of the new slate tiles was carefully chosen and the roof was completely re-shingled and re-flashed. Also, the existing limestone parapet walls were cleaned and re-pointed with a specially selected grout, since this decorative limestone needed to match the existing building façade. The restoration work for the roof, the dormers and the cornice required erecting full-height scaffolding to properly do the work.

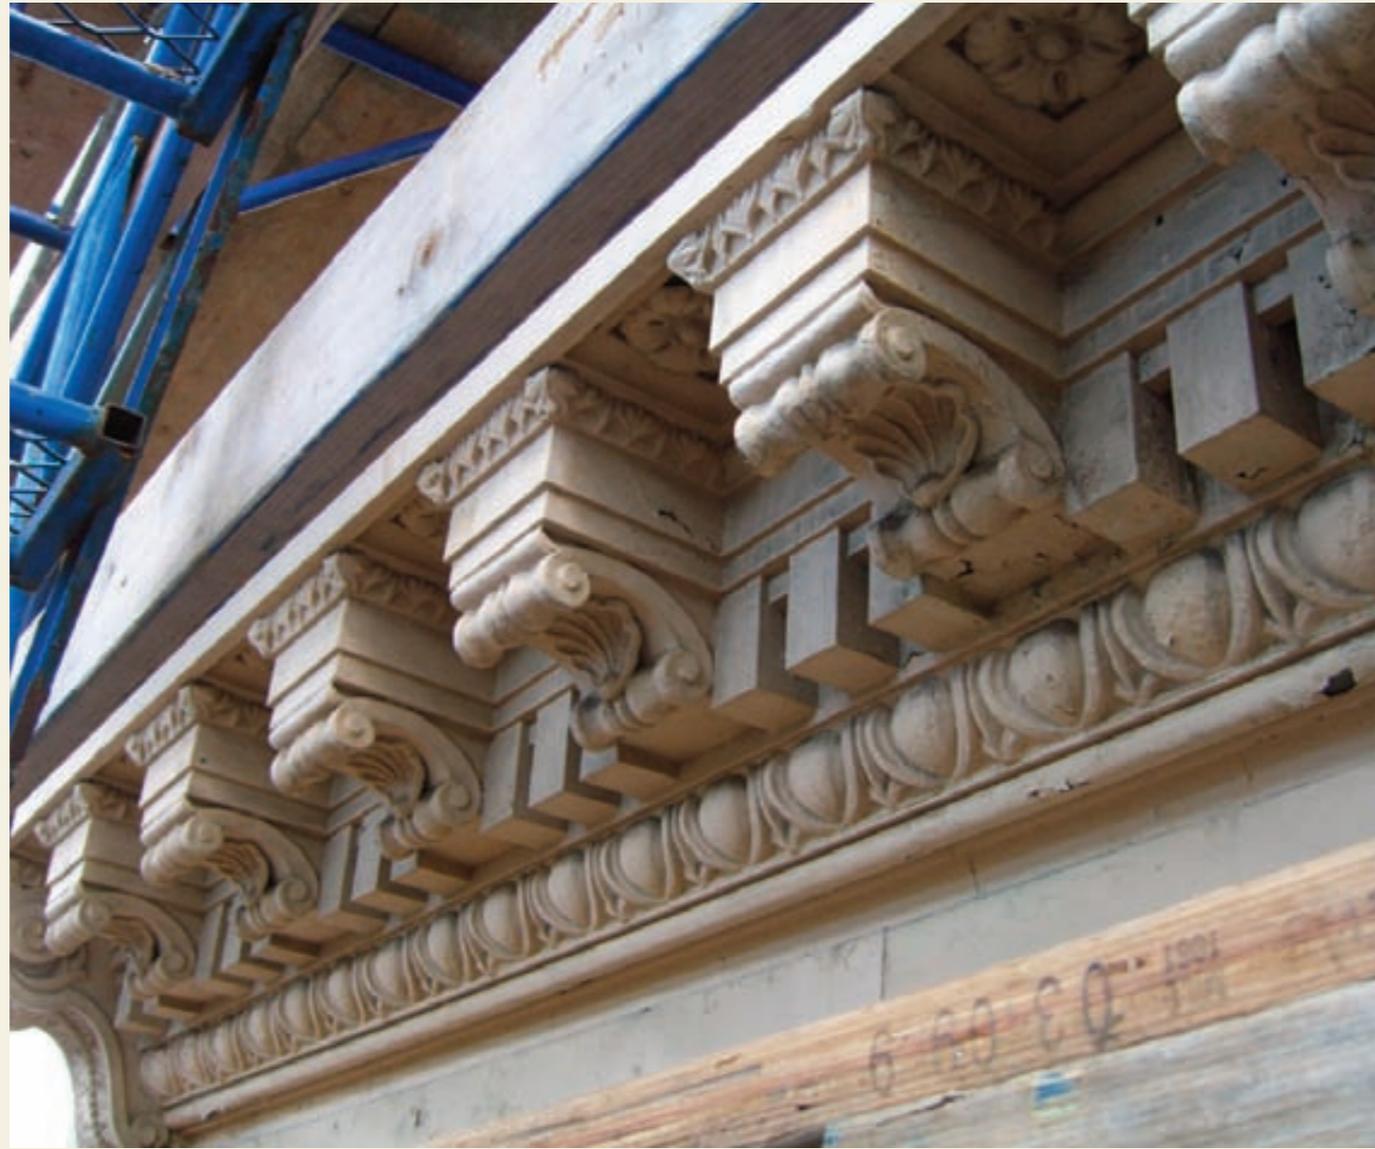
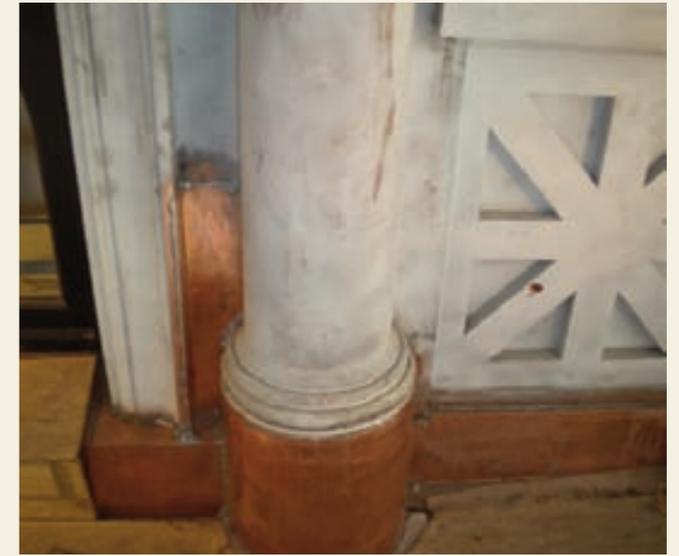
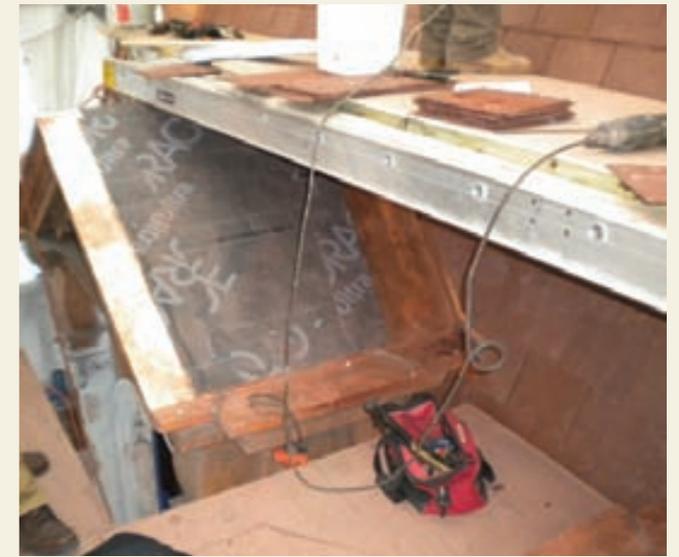
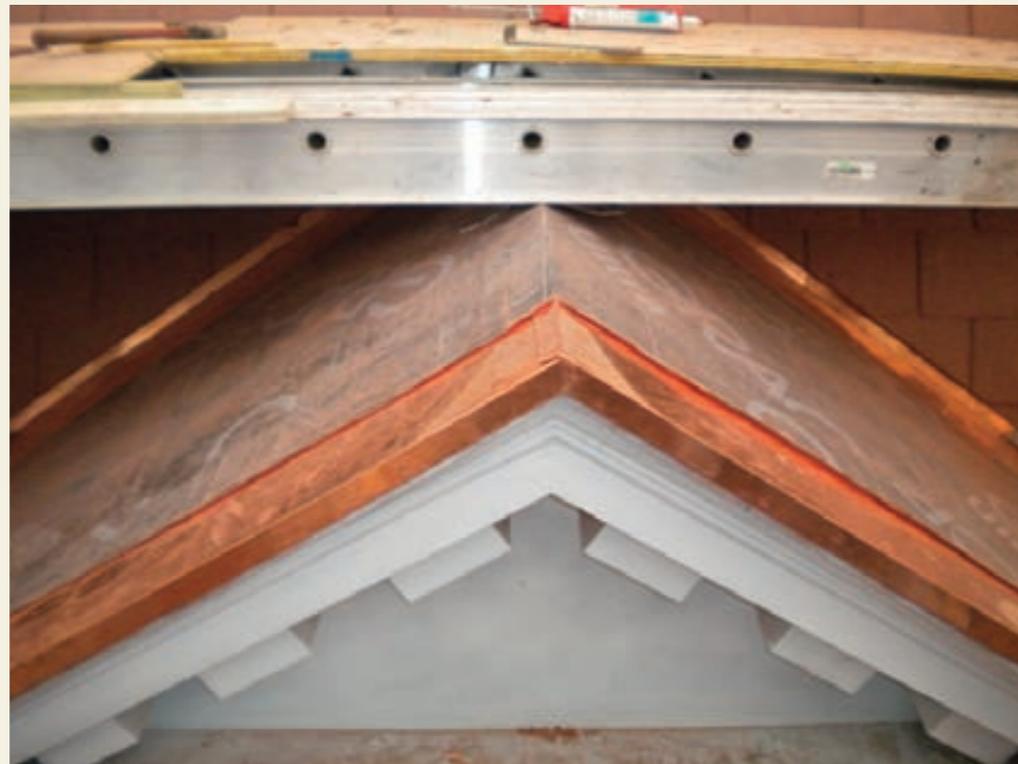
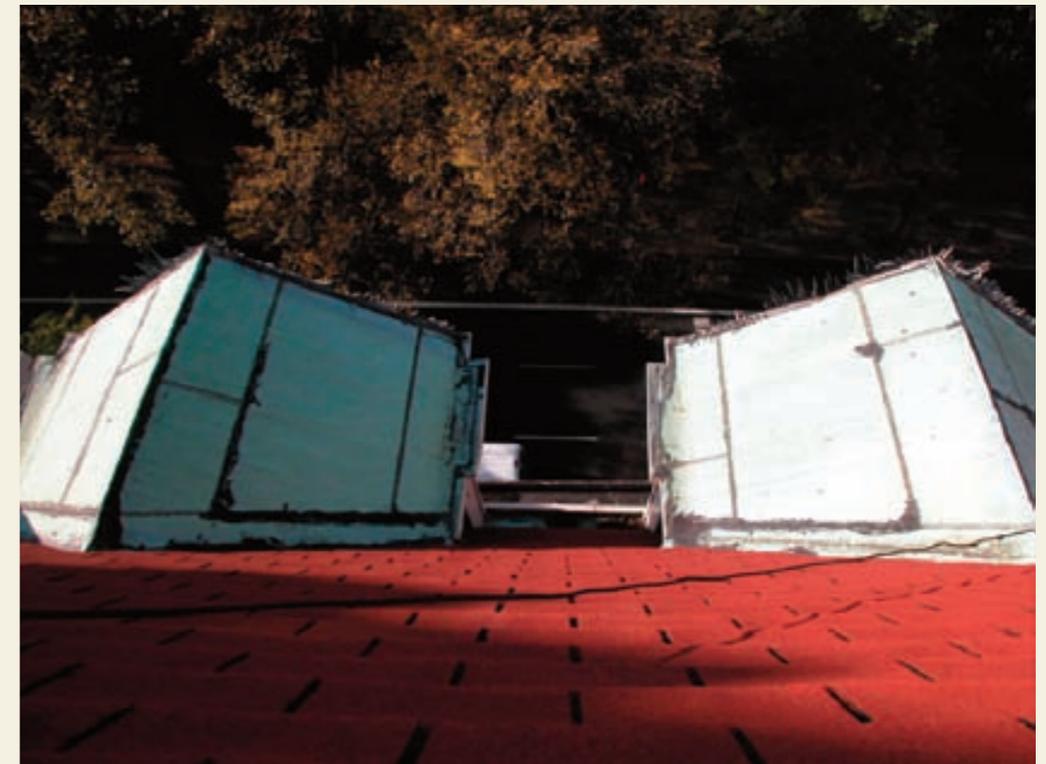
## Cornice & Dormers

The existing metal roofs of the dormers had been repaired at various times in the past and needed to be replaced. The dormers were also completely re-flashed. All of the original decorative copper details of the dormers and the cornice had been painted many times over the years and they needed to be scraped and re-finished. Many discrete portions of the metal modillions, pilasters and dentils needed to be repaired or replaced. A specialist in paint analysis was engaged to determine the color of the original paint that was used on this decorative metal work, and the new paint color was carefully chosen to match the results.

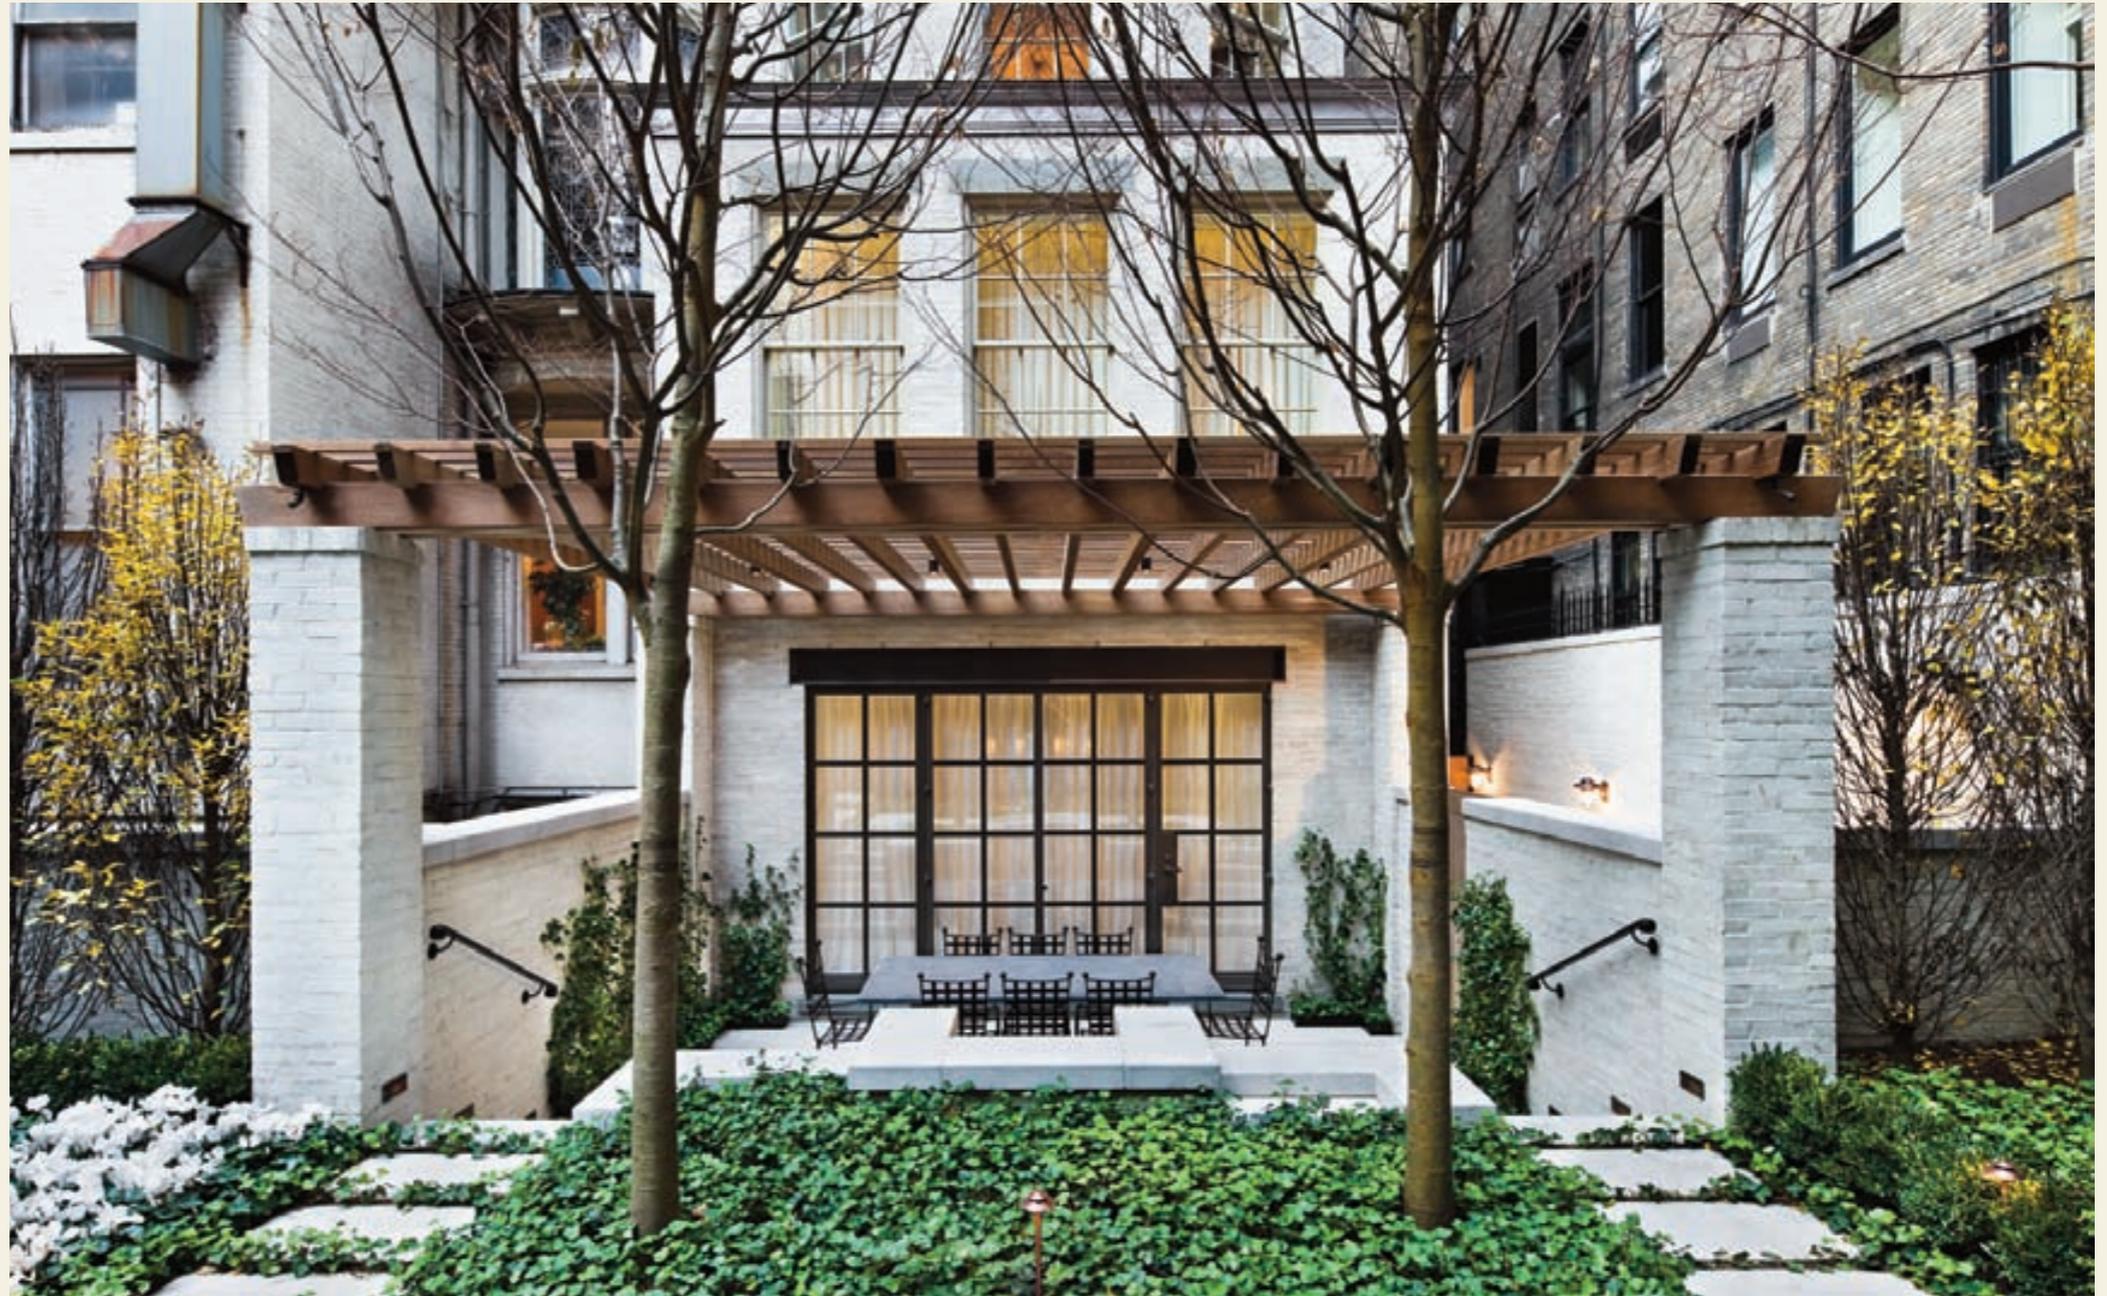
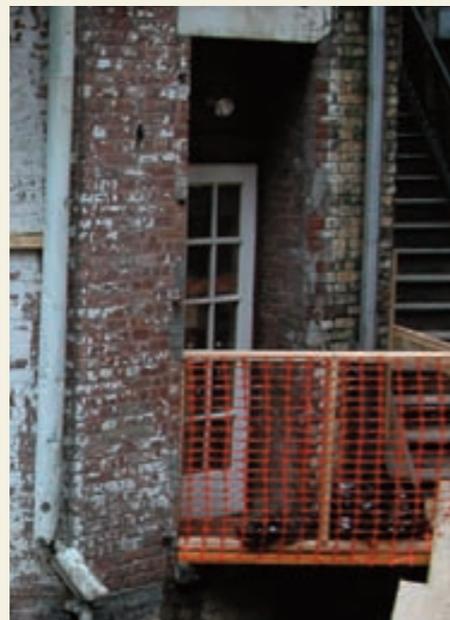
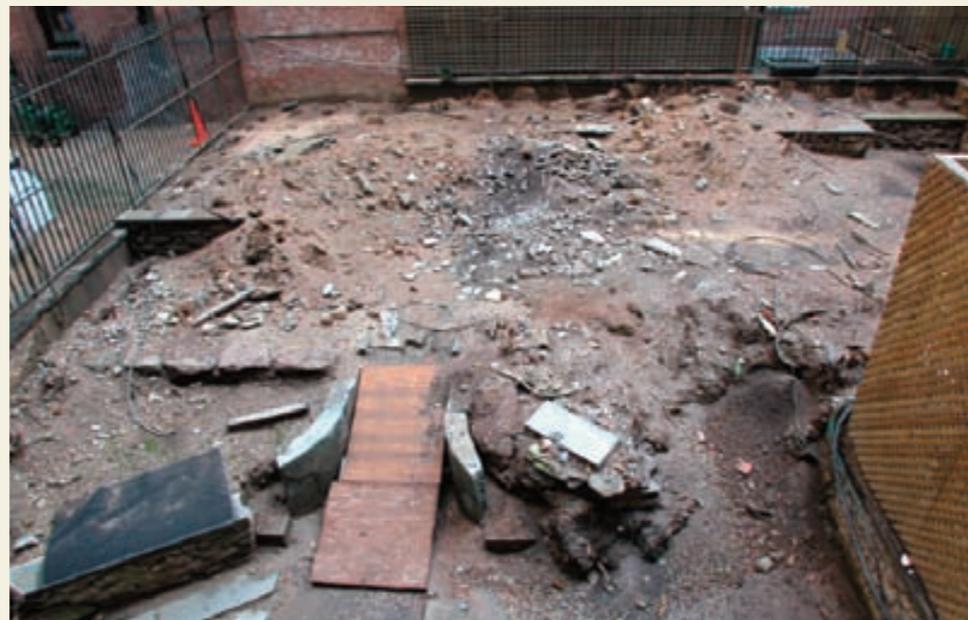
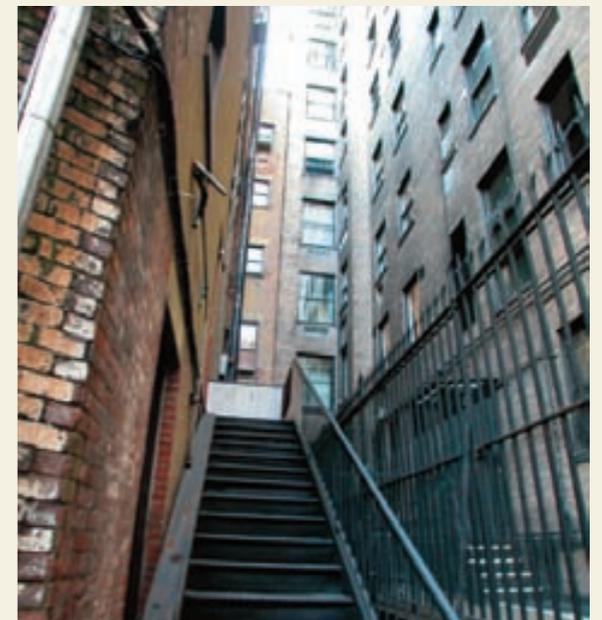
## Rear Yard

The building was purchased with the landscaping already completely removed, and the masonry of the lower portion of the building in disrepair. The LPC had previously approved the replacement of the entire rear façade with a ten foot extension. In spite of this, the new owner choose to leave most of the existing rear façade and only extend the lower two floors with a modest addition. Since the garden level was completely invisible from all public venues, the LPC felt that it was appropriate to allow a more contemporary treatment of the fenestration in this one area of the rear yard. However, the cornice of the new metal roof over the addition was designed with a traditional and historically relevant metal frieze and crown.

The new brick of the addition was chosen to match the existing brick in terms of size and coursing. An existing private covenant with the neighbors required that the brick on the rear of the building be painted white or off-white. Therefore, the existing brick was scraped and all of the brickwork was painted. The existing bluestone lintels were scraped and left unpainted along with all of the new bluestone lintels.
