RESTORING A RESIDENCE

926 Fifth Avenue

*New York City*

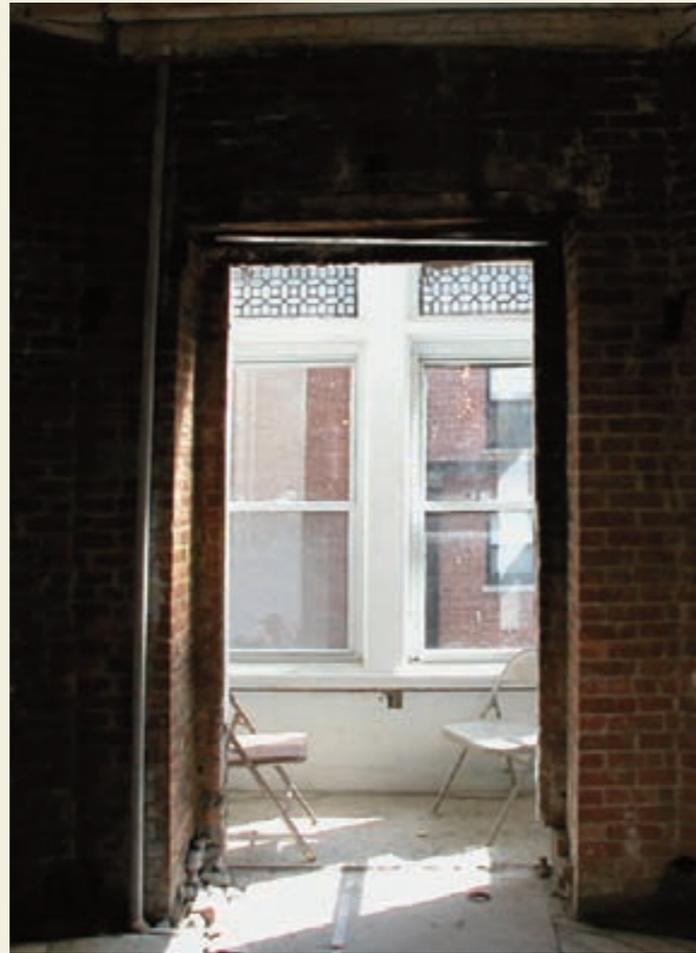
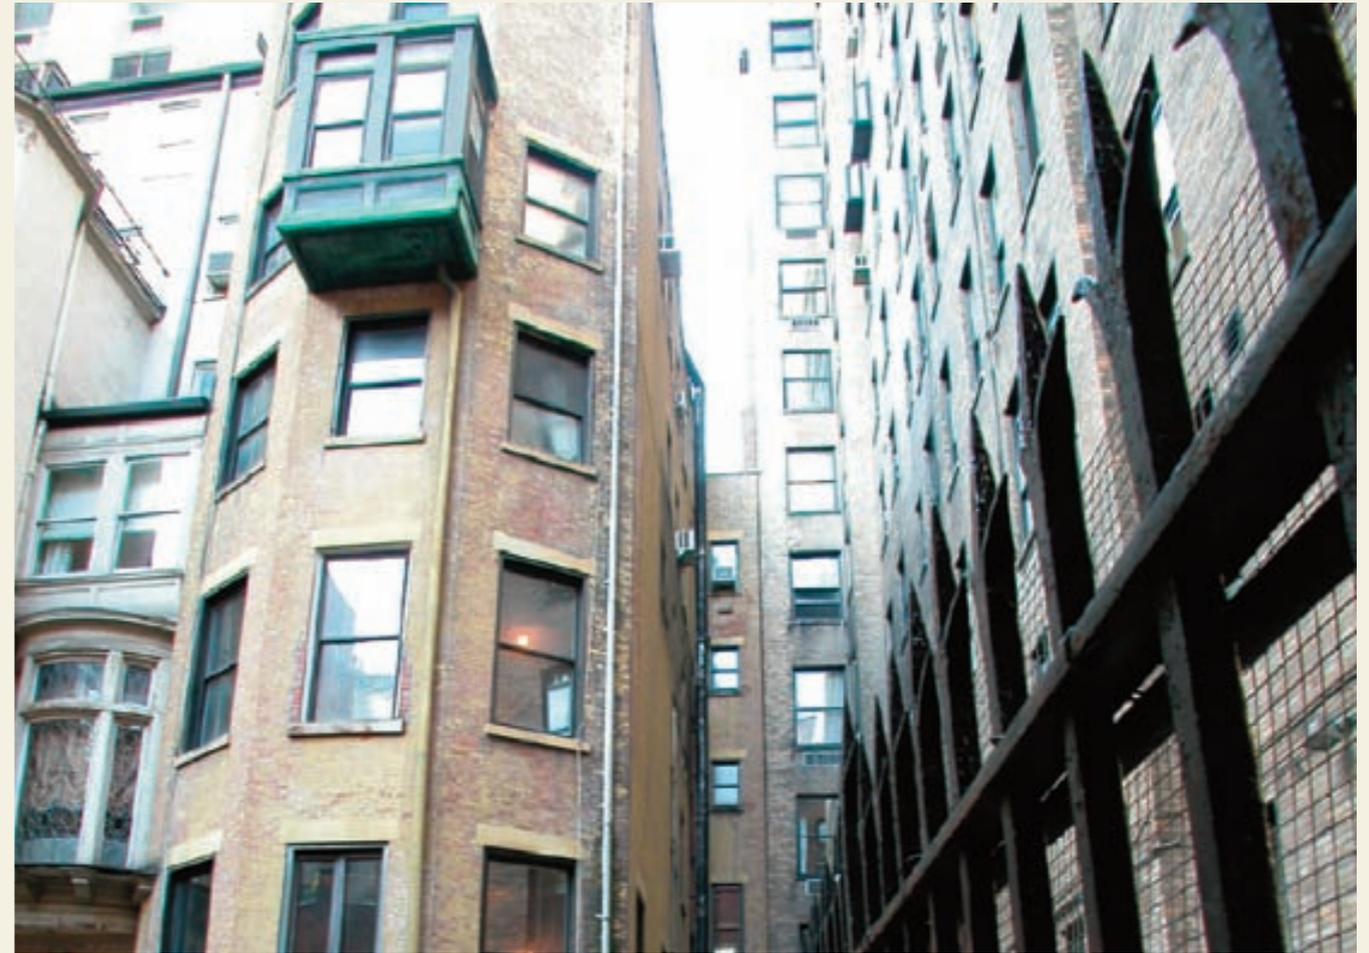
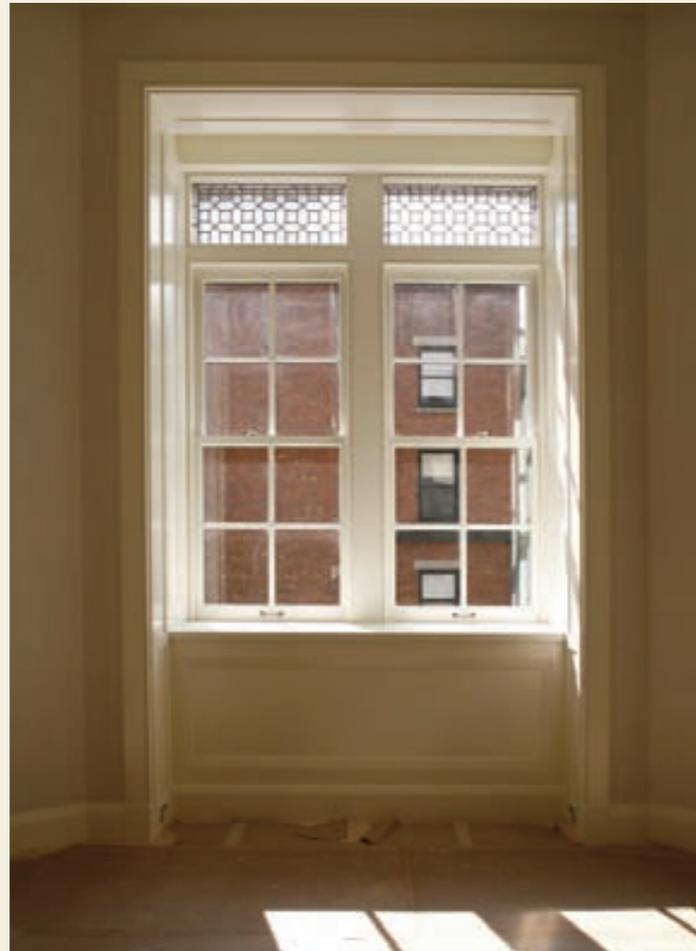
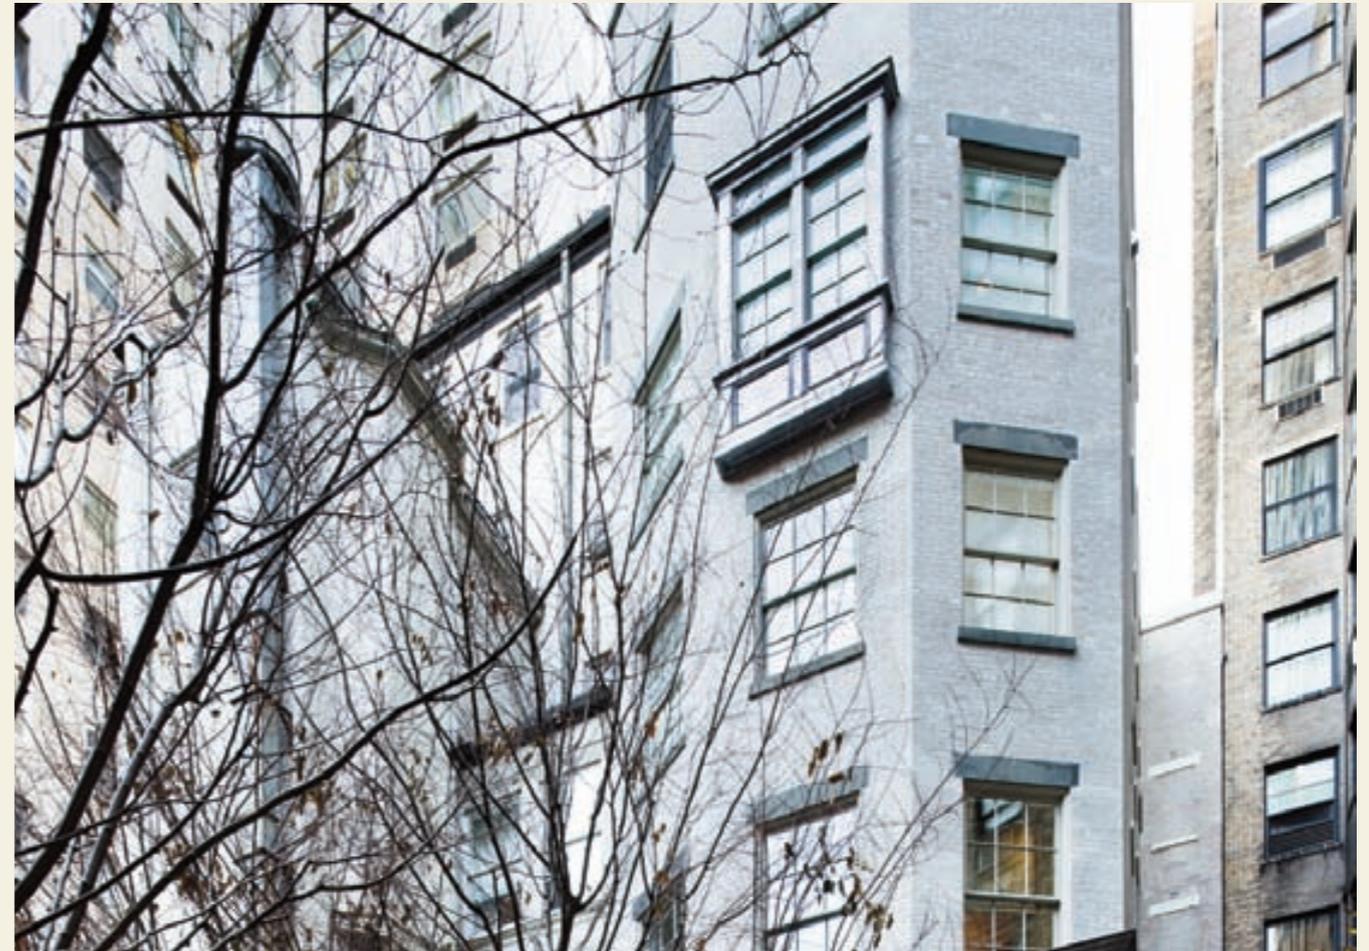
## Bay Window

Research into the original building drawings revealed that this bay window was designed as part of a two-level metal balcony or “cat walk” on this floor and the one above. There was inconclusive evidence as to whether the rest of this metal structure had ever been installed, but without the balcony, the bay window looked particularly awkward, and tenuous.

The existing copper bay window was leaking and structurally un-sound. In addition, it was extremely uncomfortable to actually be in it. Because of this, the new Owner was hoping to have it renovated or removed. The LPC had previously approved its replacement with a “flattened” version that matched it in elevation. The metal elements were carefully examined, and matching or complimentary details were designed and fabricated. In addition, most of the original decorative glass was re-used in new transoms that related to the original transoms.
